# RESTORATION OF *ARUNDINARIA GIGANTEA* (RIVERCANE) TO THE OCONOLUFTEE RIVER FLOODPLAIN, CHEROKEE, NC

GRIFFITH, Adam<sup>1</sup>, TANNER, Benjamin R.<sup>2</sup>, KINNER, David<sup>2</sup>, and YOUNG, Robert S.<sup>1</sup>, (1) Program for the Study of Developed Shorelines, Western Carolina University, 90 University Way, Belk Building Room 294, Cullowhee, NC 28723, agriffith@wcu.edu, (2) Geosciences & Natural Resources, Western Carolina University, 335 Stillwell Bldg, Cullowhee, NC 28723

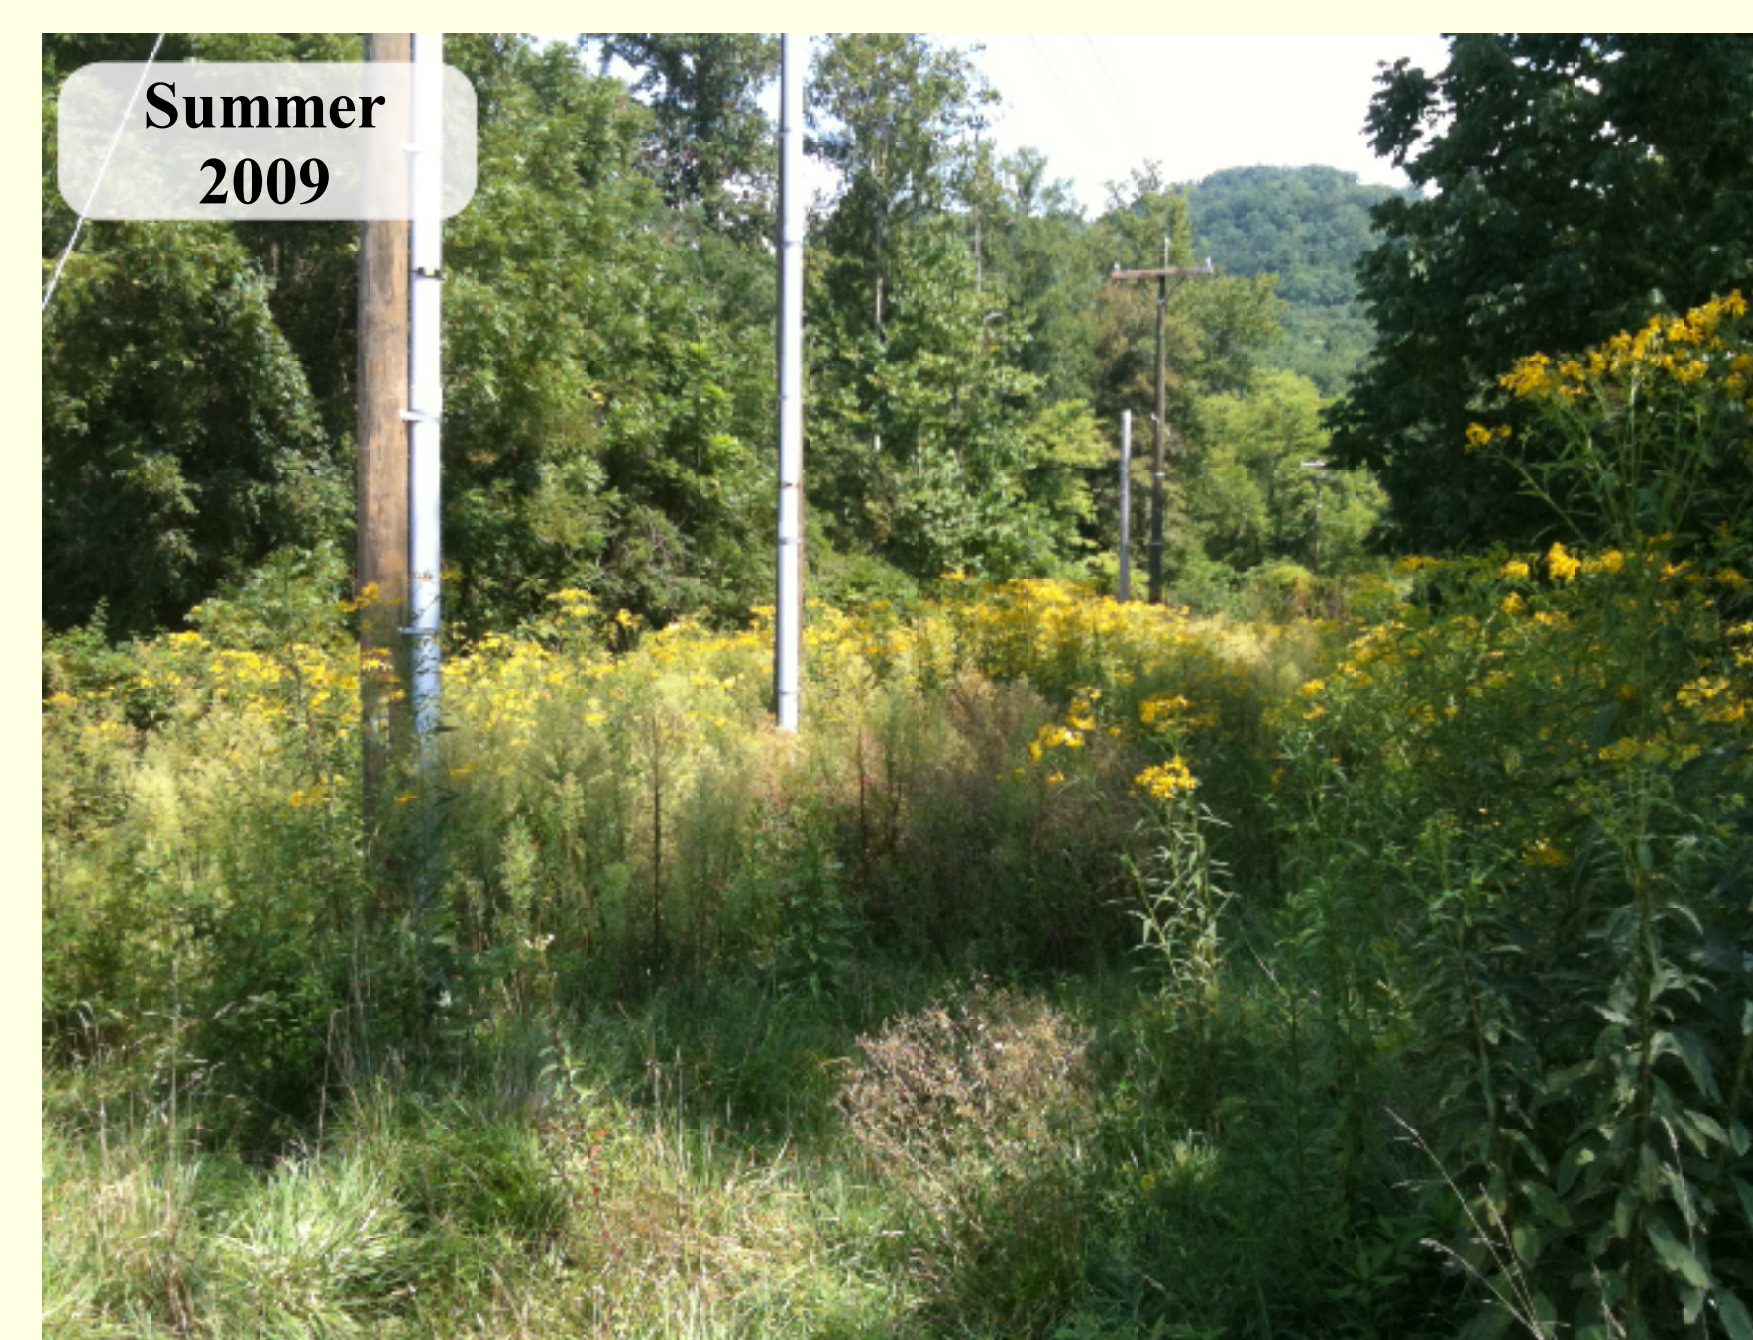
Before construction began, the site was rich with non-natives and even a few wetland species.

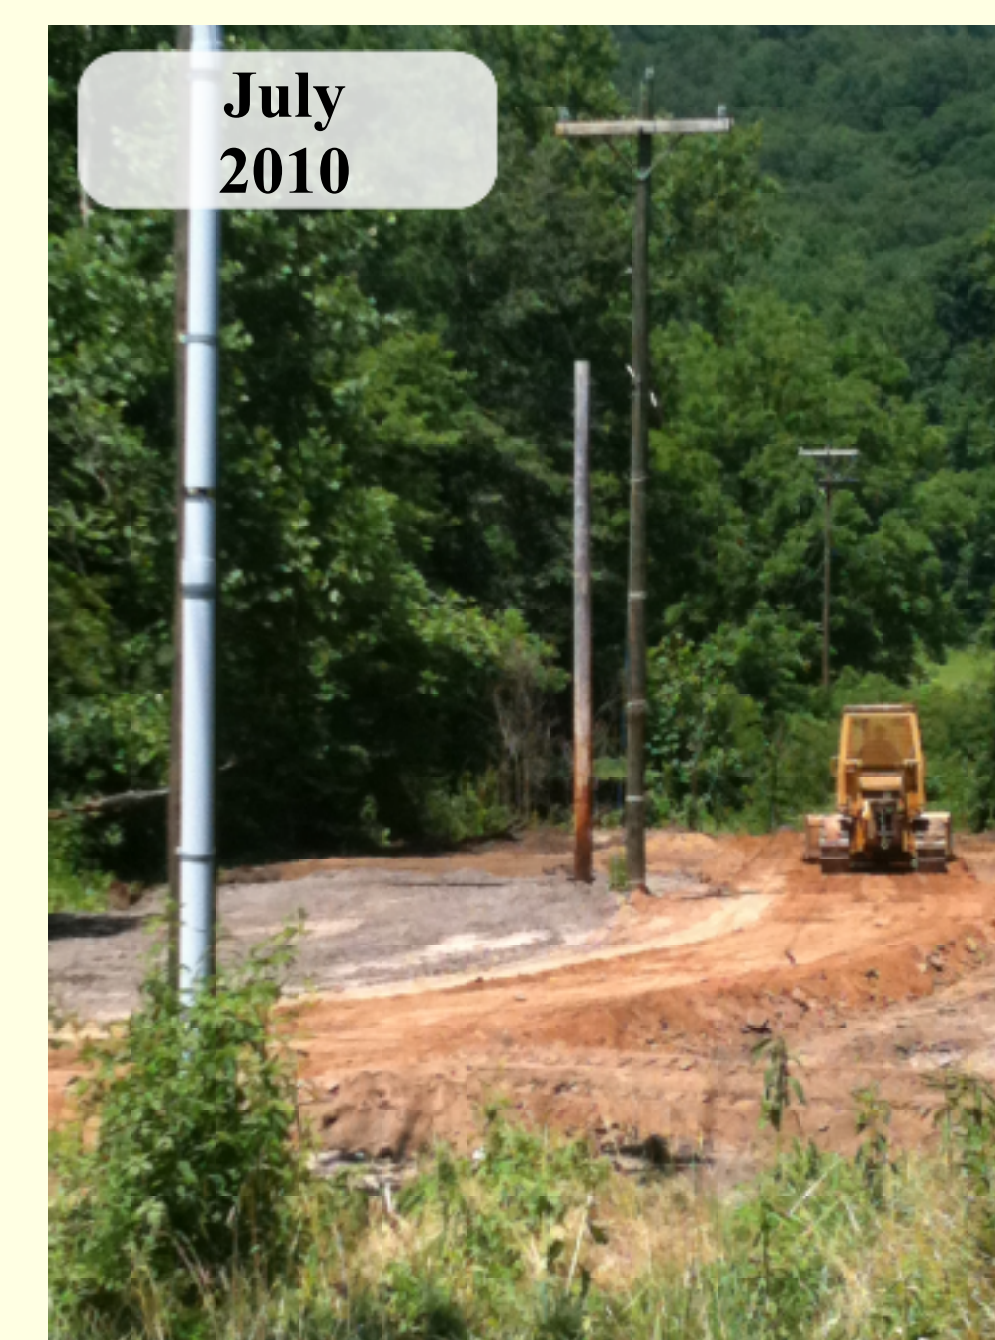
Road construction underway to secure the right-of-way under the power lines.

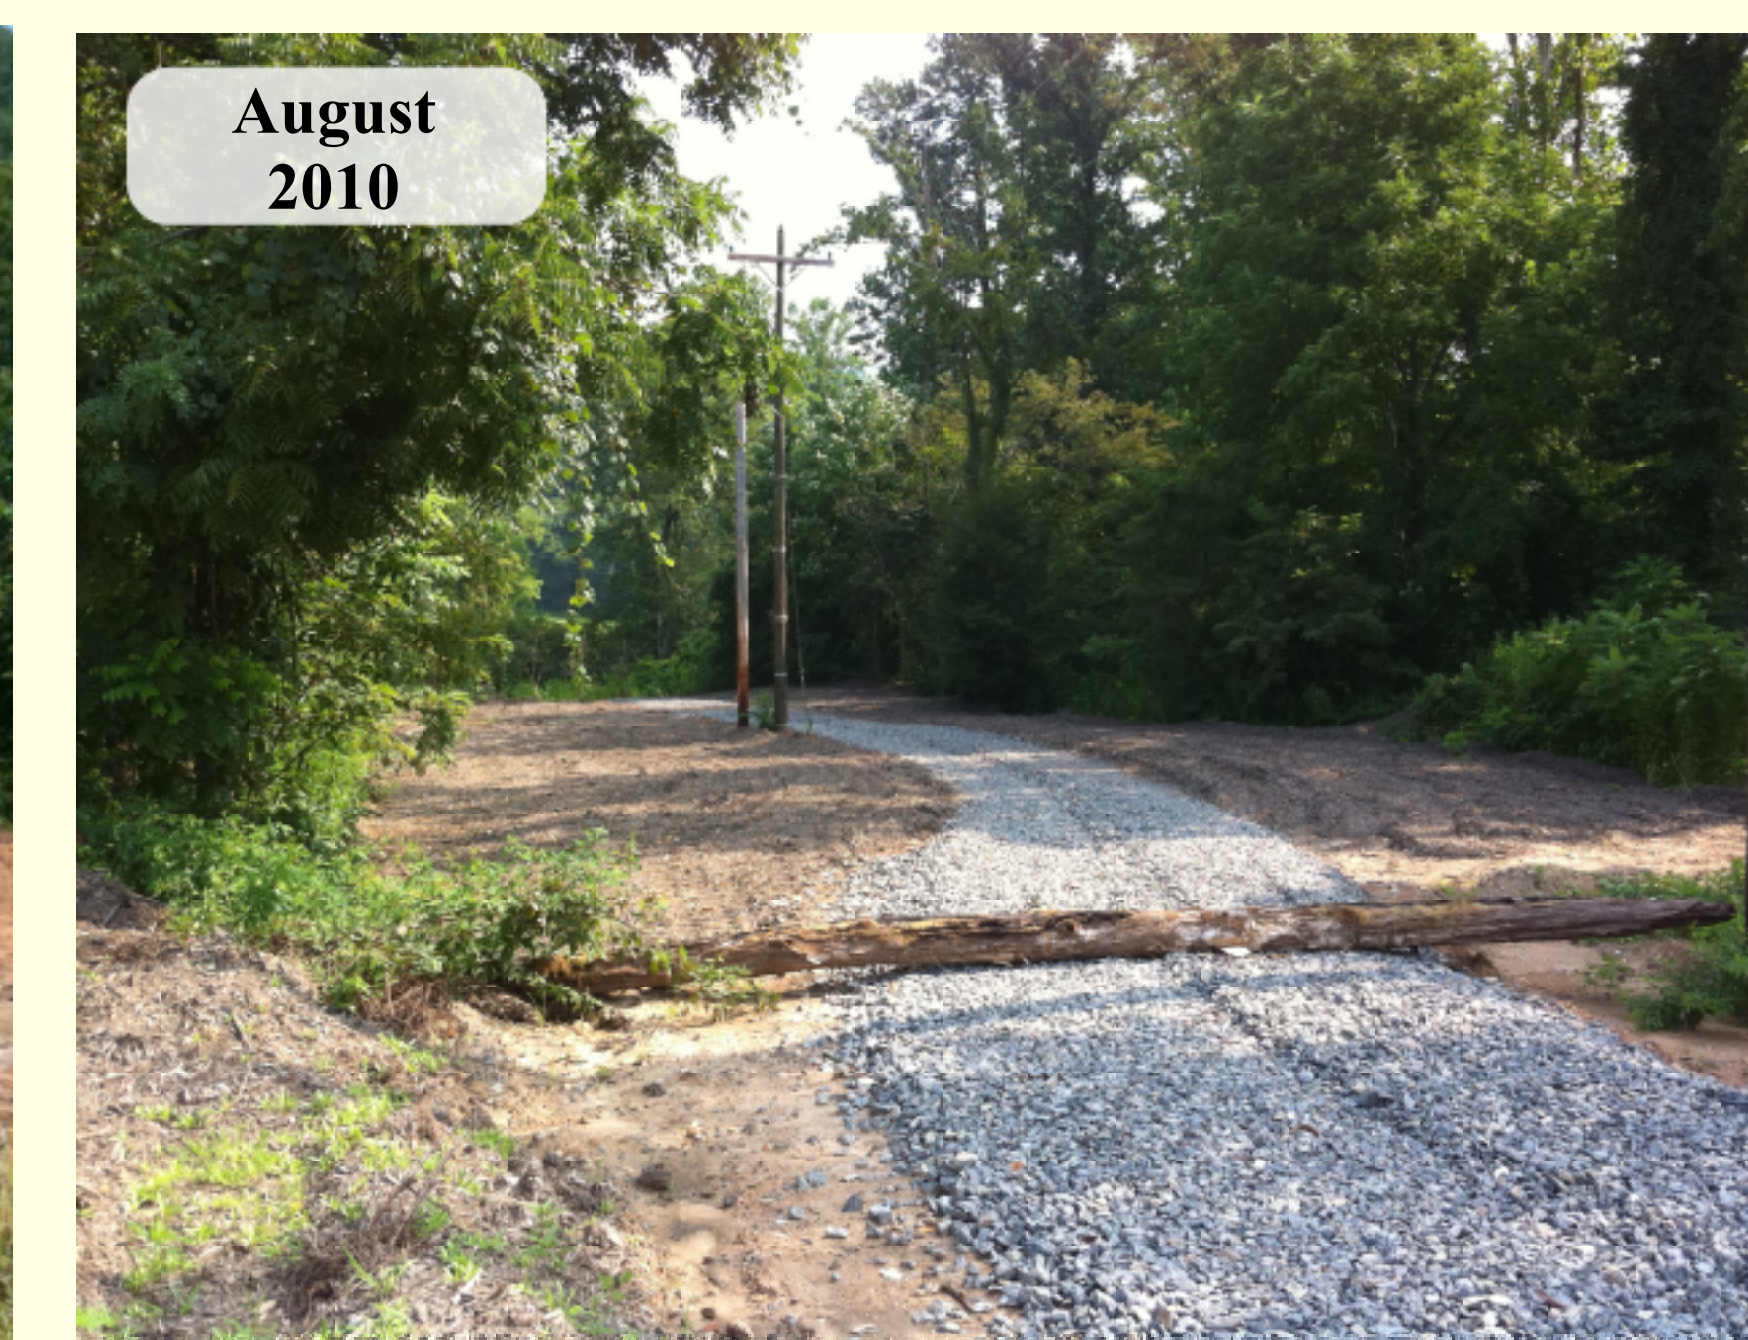
Site preparations are completed very close to the specifications of the landscape architect.

Information and data gathered from 2005 - 2009 has guided the planning and establishment of pilot restoration plots of rivercane on tribal land at the campus of Cherokee Central Schools. To reduce the likelihood of hydric soil formation, the site elevation was raised 40-45 cm with a mixture of 40% sand, 40% top-soil, and 20% mulch. The 700 cubic meters of amended soil increases infiltration rate, reduces bulk density, and provides nutrients to the restored rivercane.

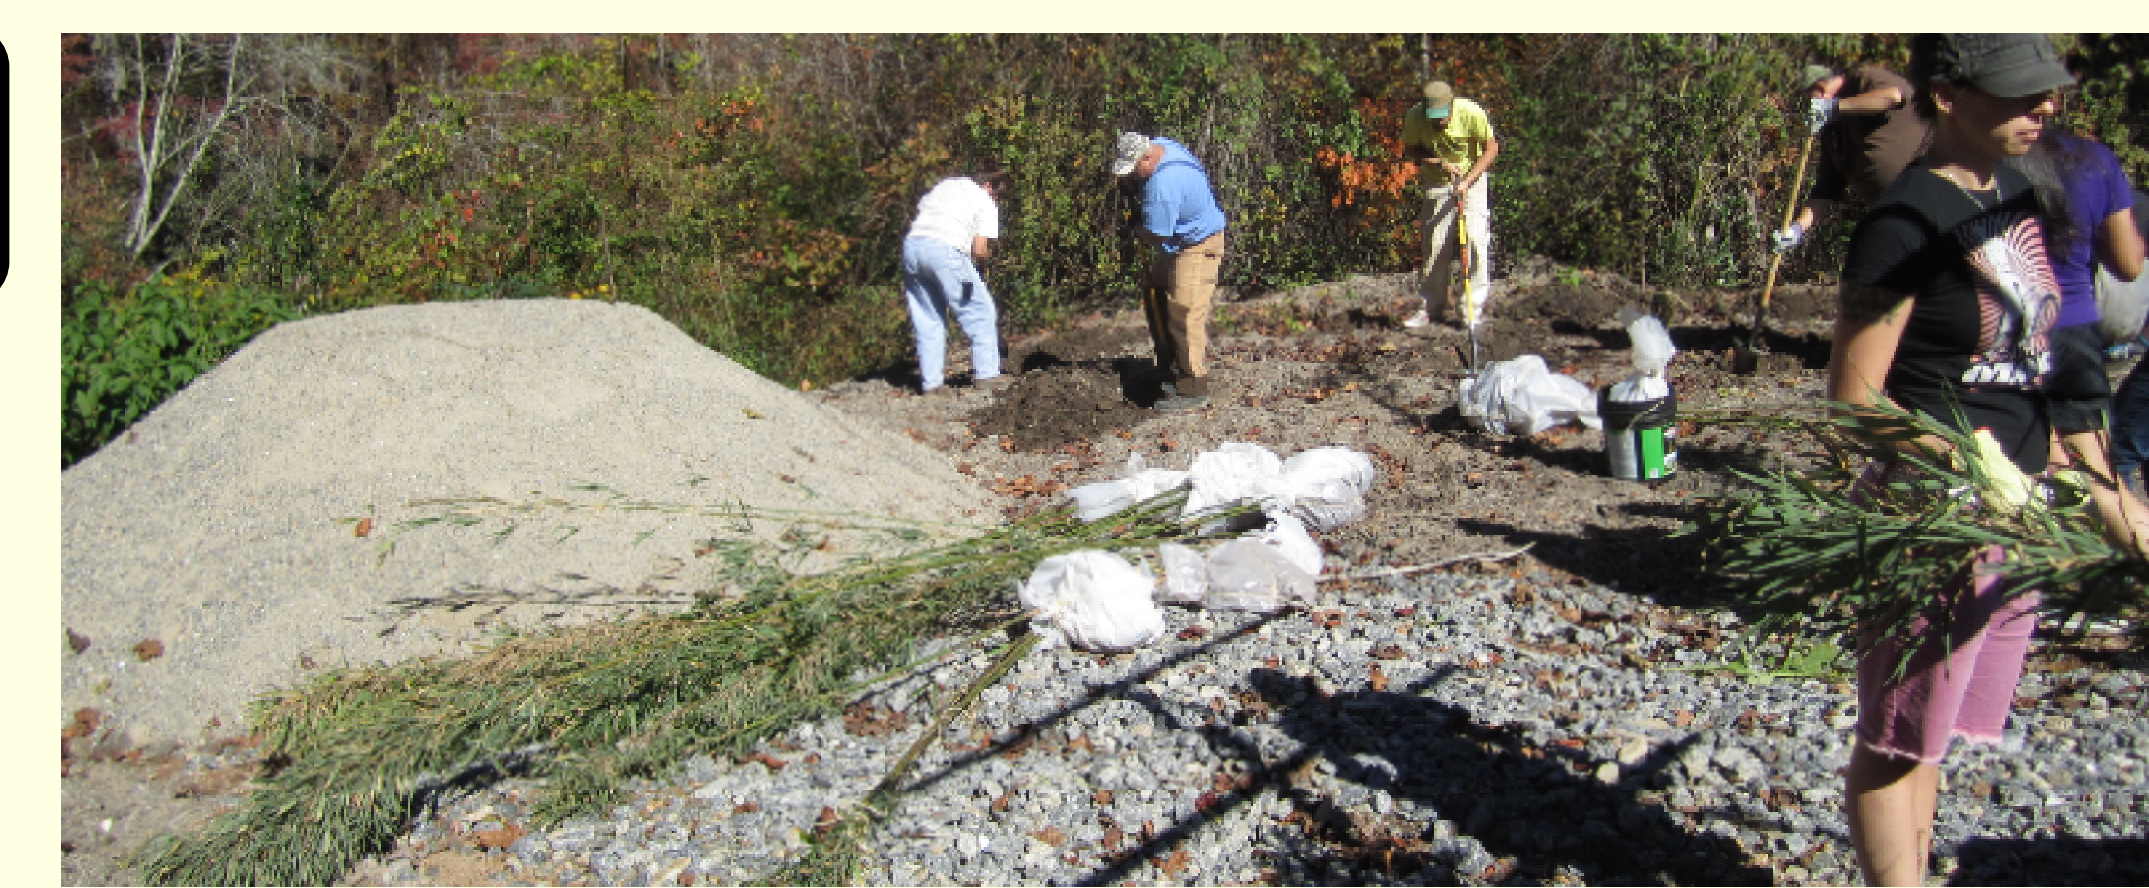
Note the length of the plants in the photo at left. A trailer was used for transport and plants wrapped in tarps for protection.

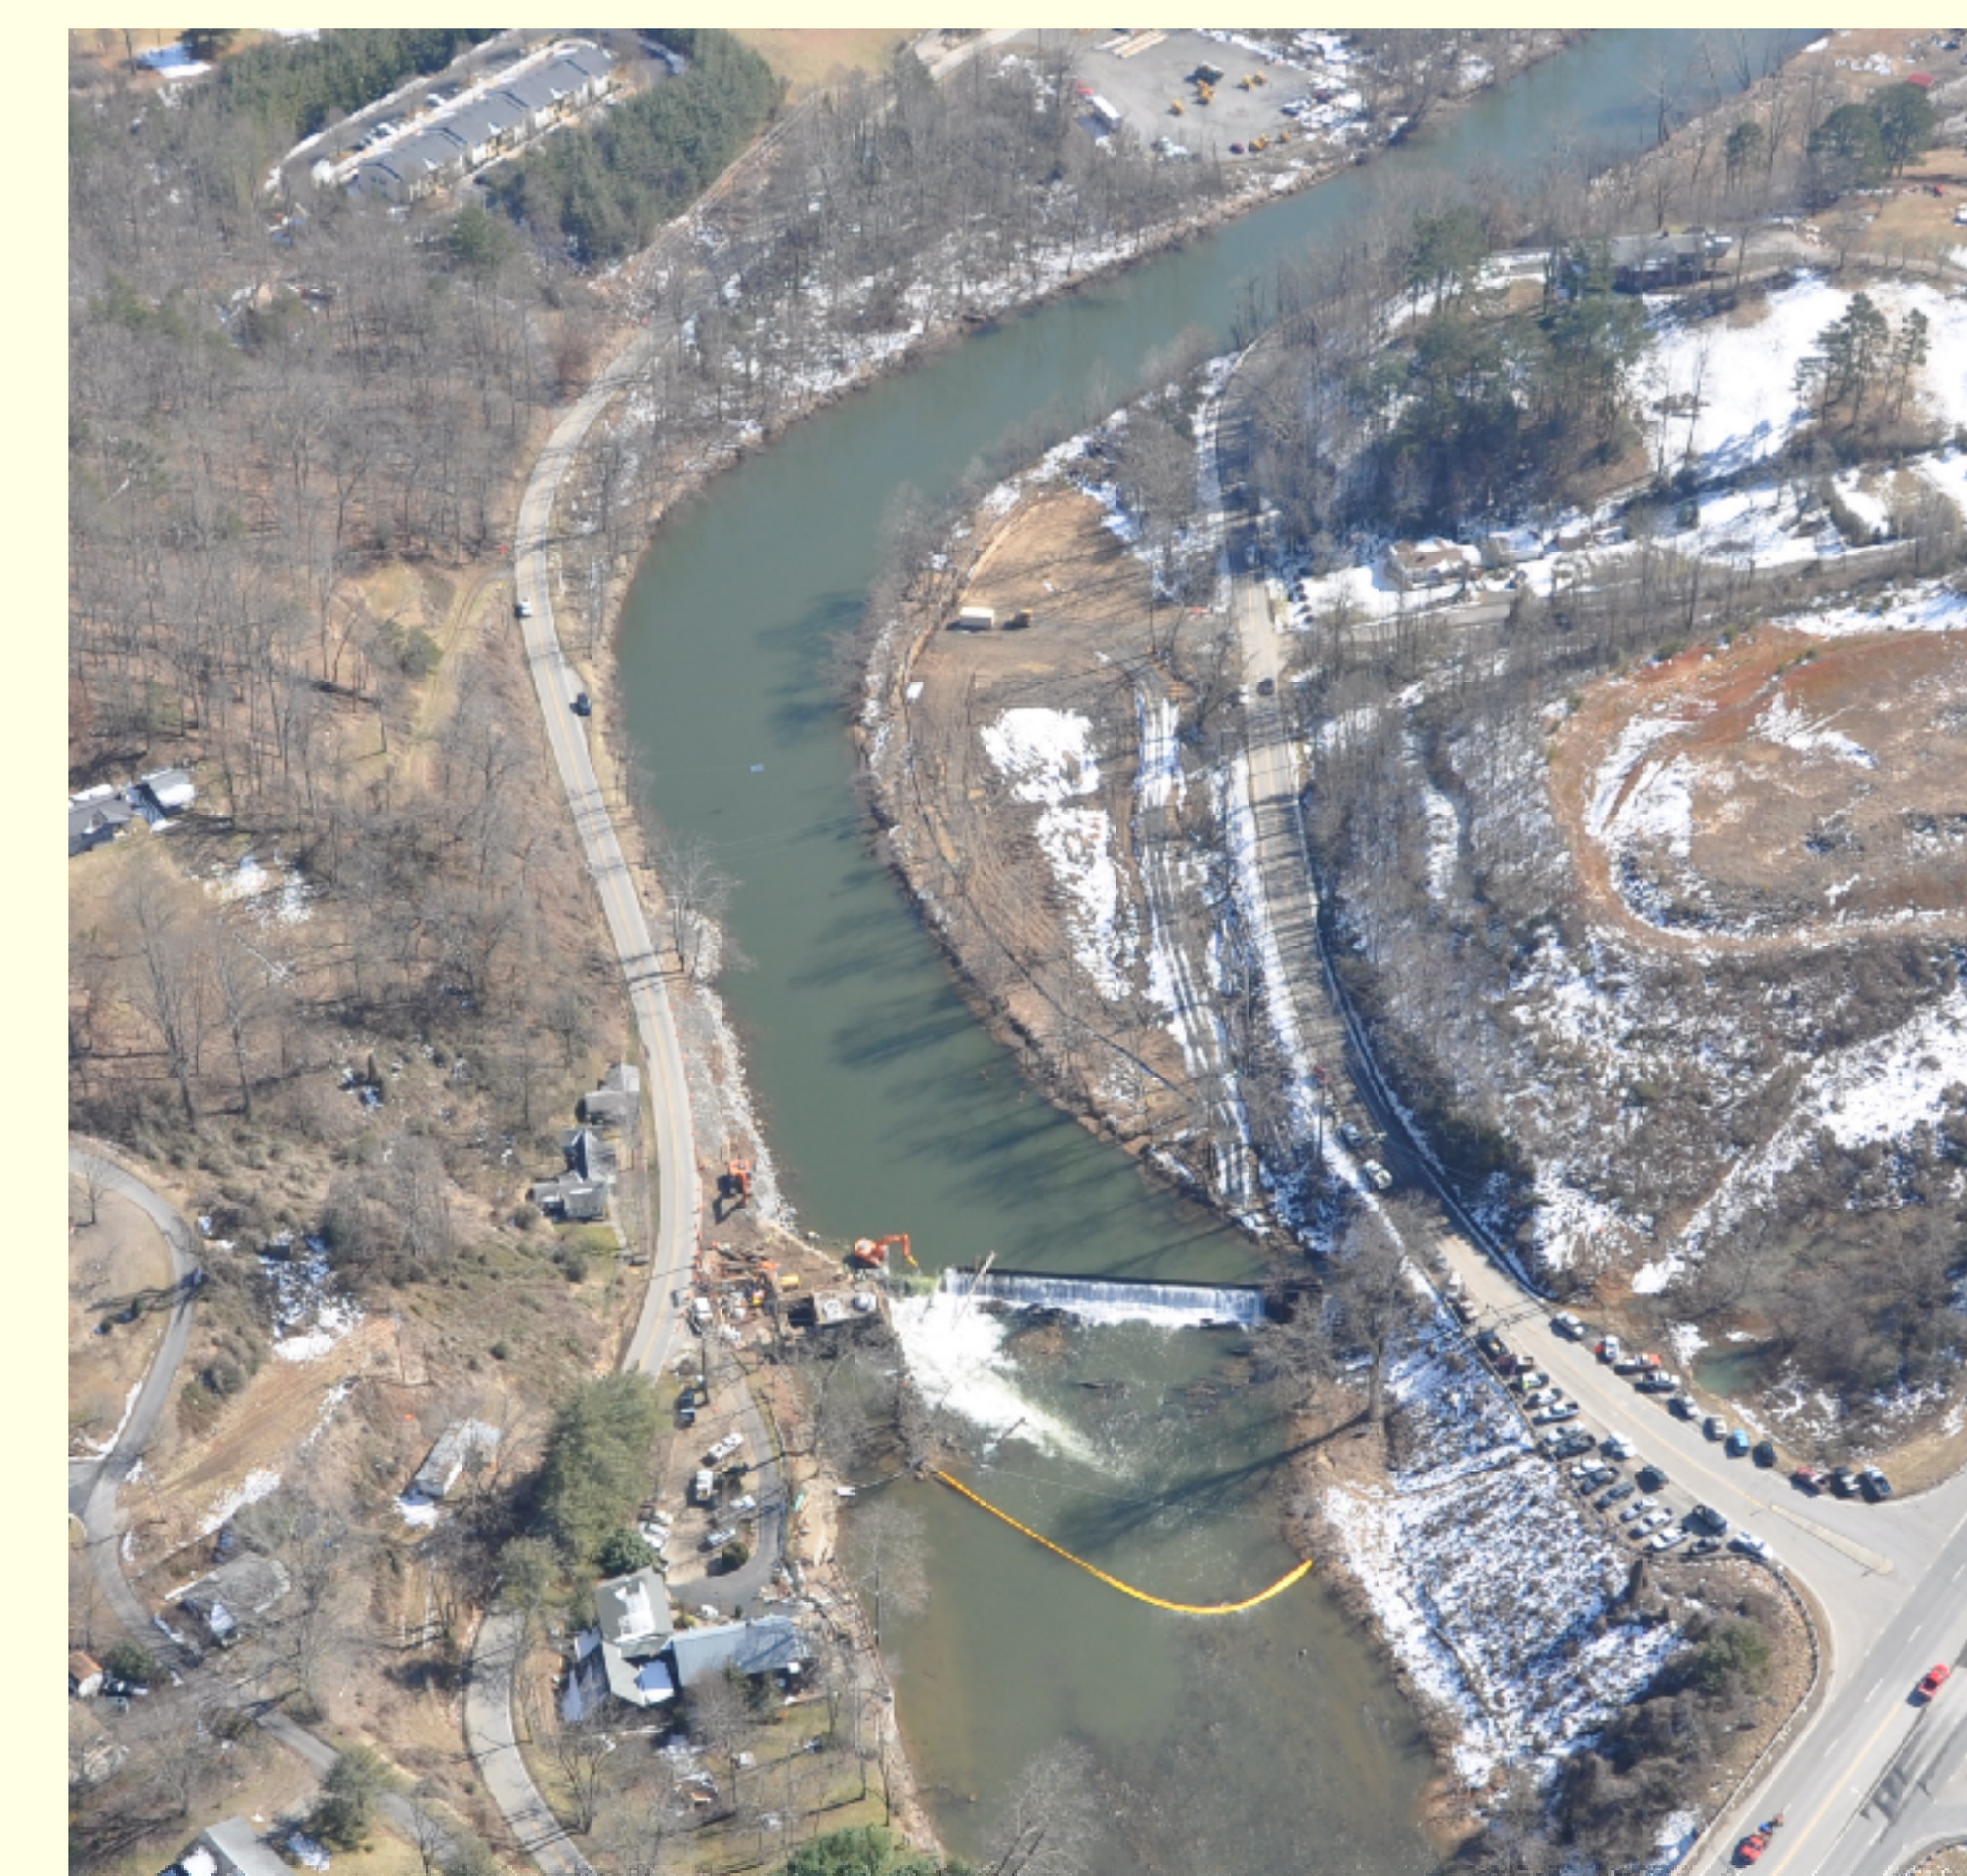
This large dam removal project has produced ideal restoration sites for rivercane previously covered by water.

The nearby town of Dillsboro, NC is another possible restoration location. A recent \$500,000 dam removal project on the Tuckaseegee river has generated interest as a restoration site for rivercane.

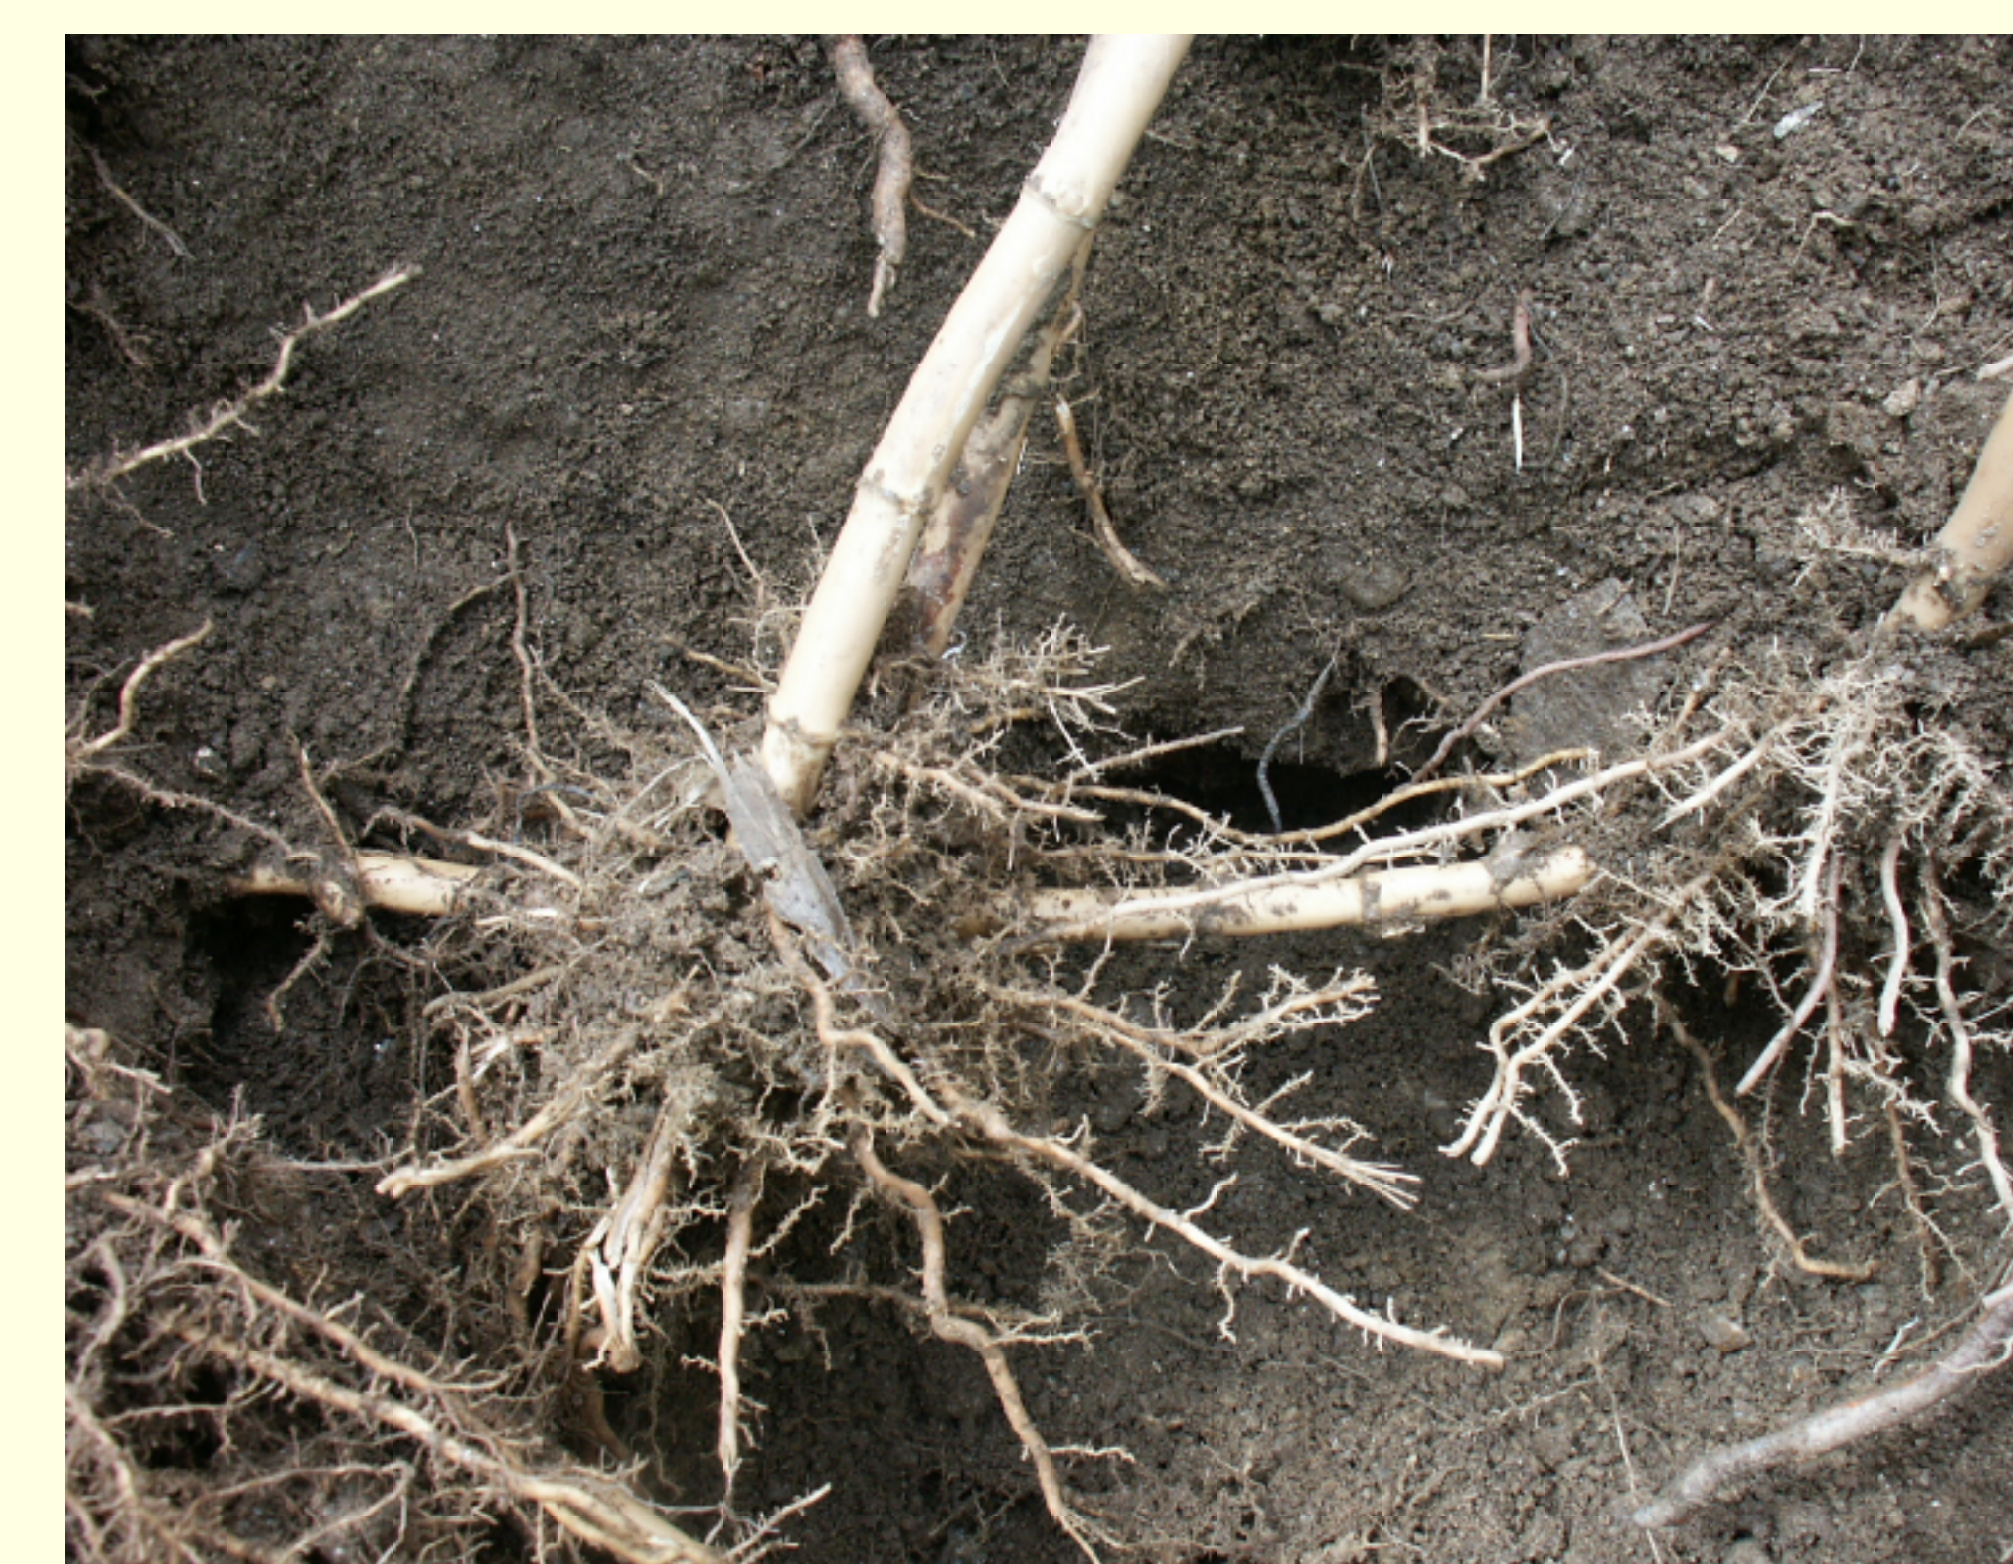
The dense network of rhizomes and roots make the transplanting very labor intensive.
